OLGA BRENER INTERMEDIATE SCHOOL BIKE/WALK AUDIT RESULTS

Audit Conducted 10.19.2011 - P.M.

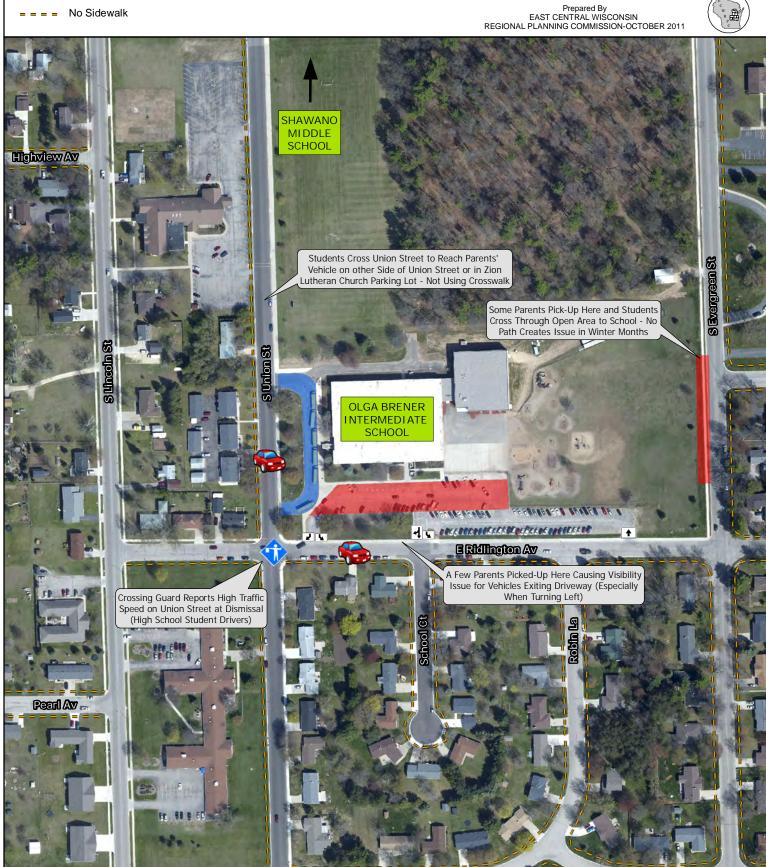
High Traffic Volume at Dismissal

Crossing Guard

No Sidewalk

Area Used by Most Parents to **Pick-Up Students**

Bus Loading Area
